May 26, 2022

SB 326 Summary and Report

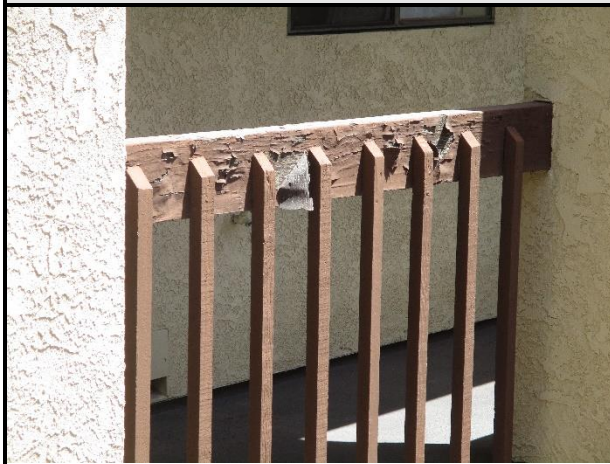
Typical Handrail Showing Deterioration

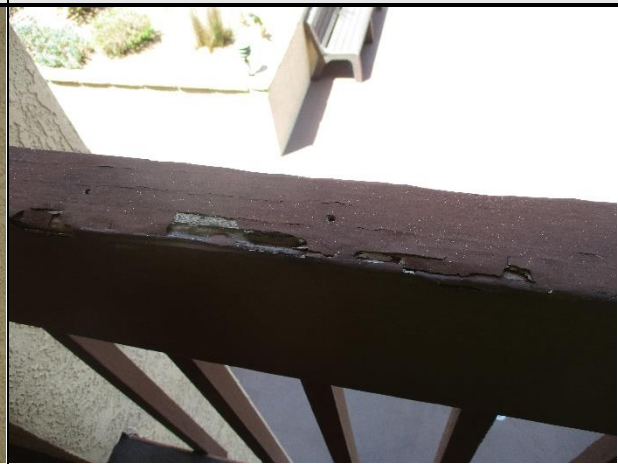
Handrail with Termite Damage

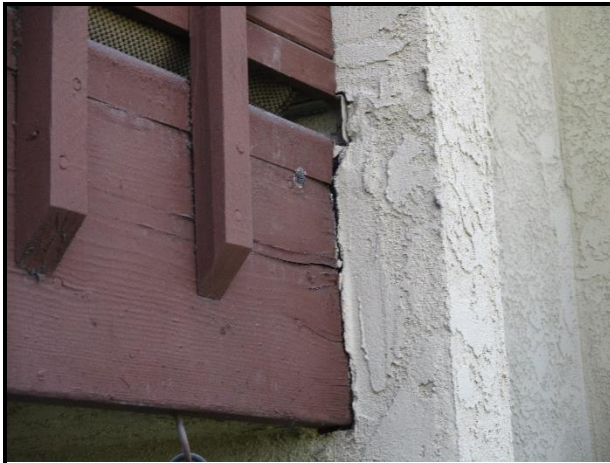
Balcony with Poor End Flashing

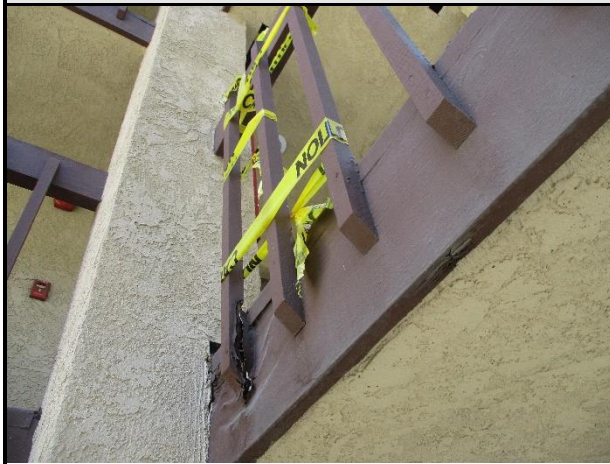
Picket and Fascia Deterioration

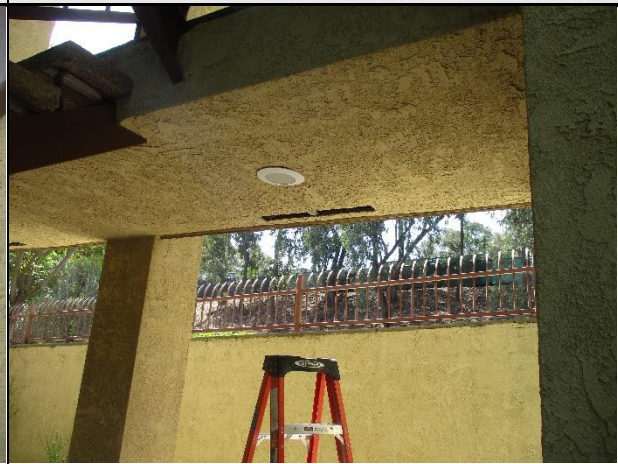
Typical Vent Opening

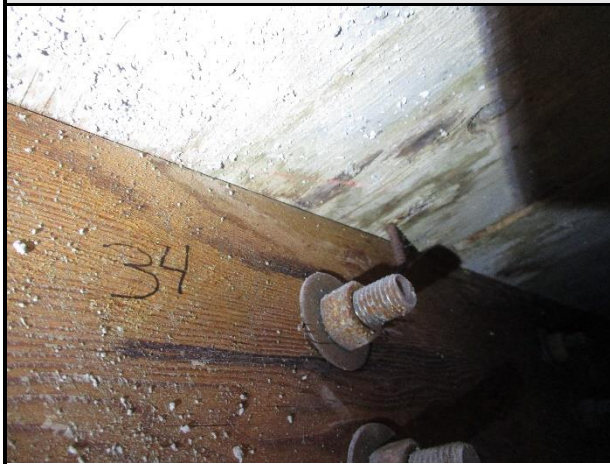
Corrosion on Bolts, Unbacked Fastener, Discoloration at Vent #34

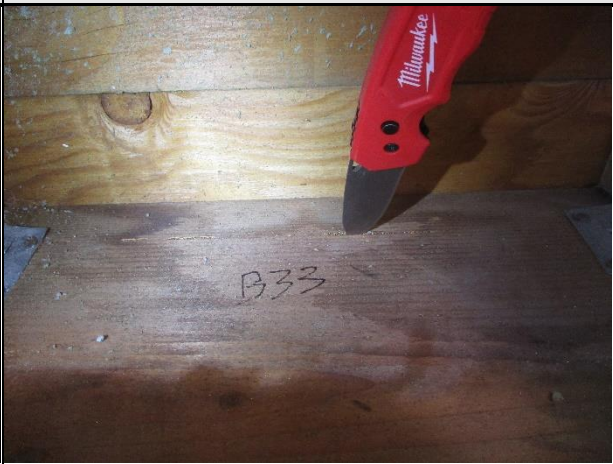
Vent B33, Discoloration and Potential Termites

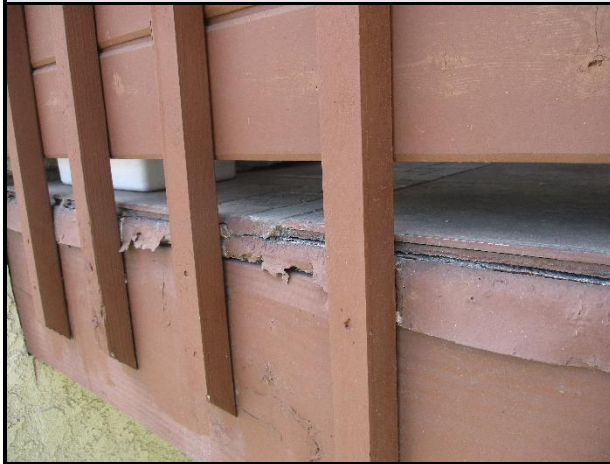
Deteriorated Flashing

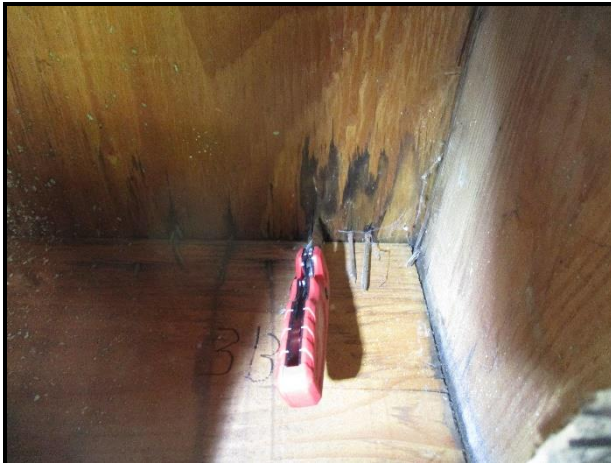
Unit 313 Discoloration and Localized Rot

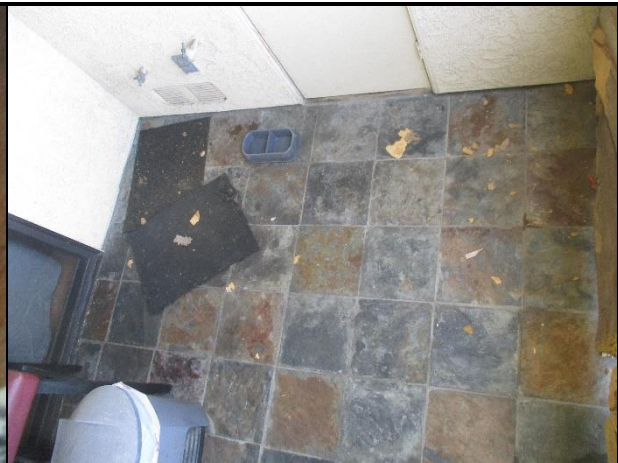
Tile on Balconies Void Deck Waterproofing Warranties

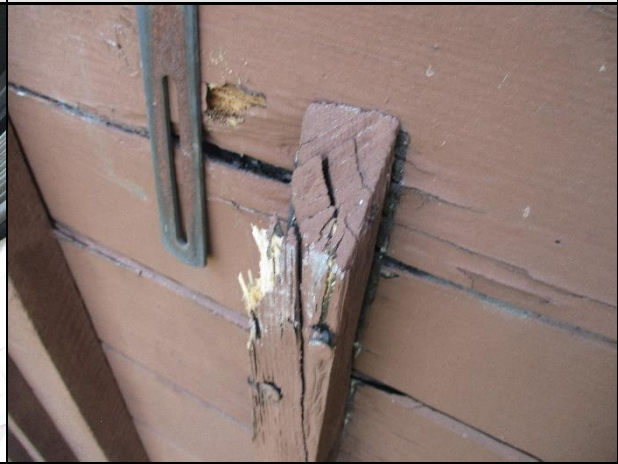
Termite Damage and Broken Picket

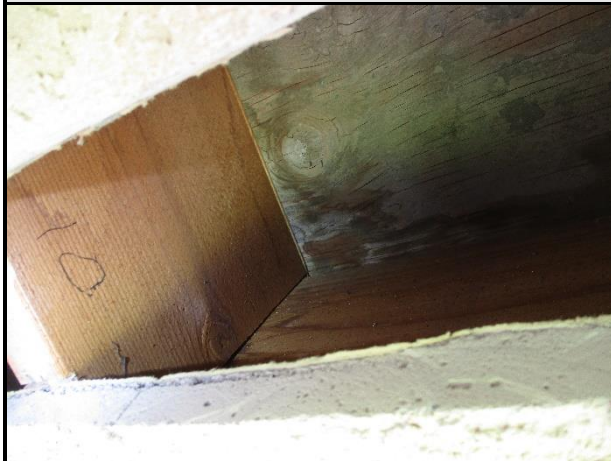
Sample Discoloration

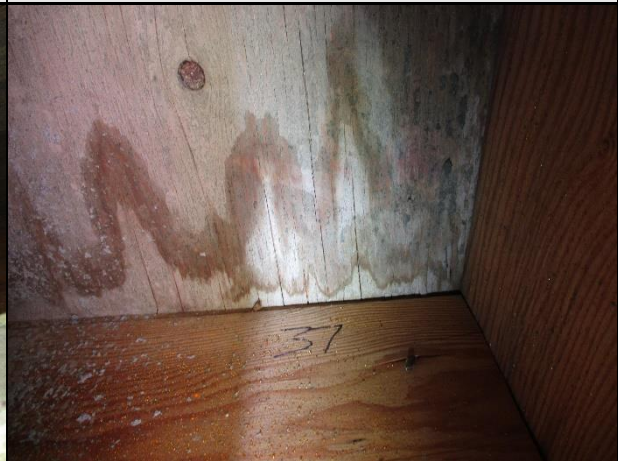
Sample Discoloration
